## CASE STUDY

# Reliable access for process tower refurbishment at Hydro Polymers, Sweden

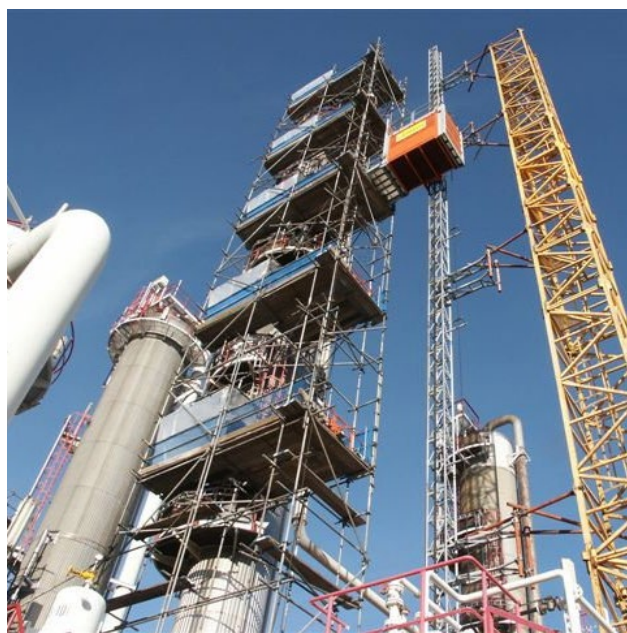
A freestanding hoist installation was engineered using a tower crane mast as the supporting structure. The hoist mast was secured using a substantial counterweight arrangement consisting of approximately 40 tonnes of ballast at the base, creating a robust and stable access solution.

The Alimak Scando 450 9/30 construction hoist provided reliable vertical transportation for personnel, tools and materials throughout the refurbishment period, supporting efficient workflow across all working levels.

The process tower's design prevented the hoist mast from being tied directly to the structure. As a result, a fully freestanding installation had to be developed, while still providing the stability required for reliable operation at height.

Adding to the complexity, the scaffold and hoist needed to remain structurally independent. A 40 cm clearance gap was incorporated between the tower and the hoist installation to allow both structures to move independently under high wind conditions without compromising safety or performance.
